SARGAND, SHAD M.; VEGA-POSADA, CARLOS A.; ARBOLEDA-MONSALVE, LUIS G.
LONG TERM PERFORMANCE OF EXISTING PORTLAND CEMENT CONCRETE PAVEMENT
SECTIONS – CASE STUDY

Dyna, vol. 81, núm. 183, febrero, 2014, pp. 40-48

LONG TERM PERFORMANCE OF EXISTING PORTLAND CEMENT CONCRETE PAVEMENT SECTIONS – CASE STUDY

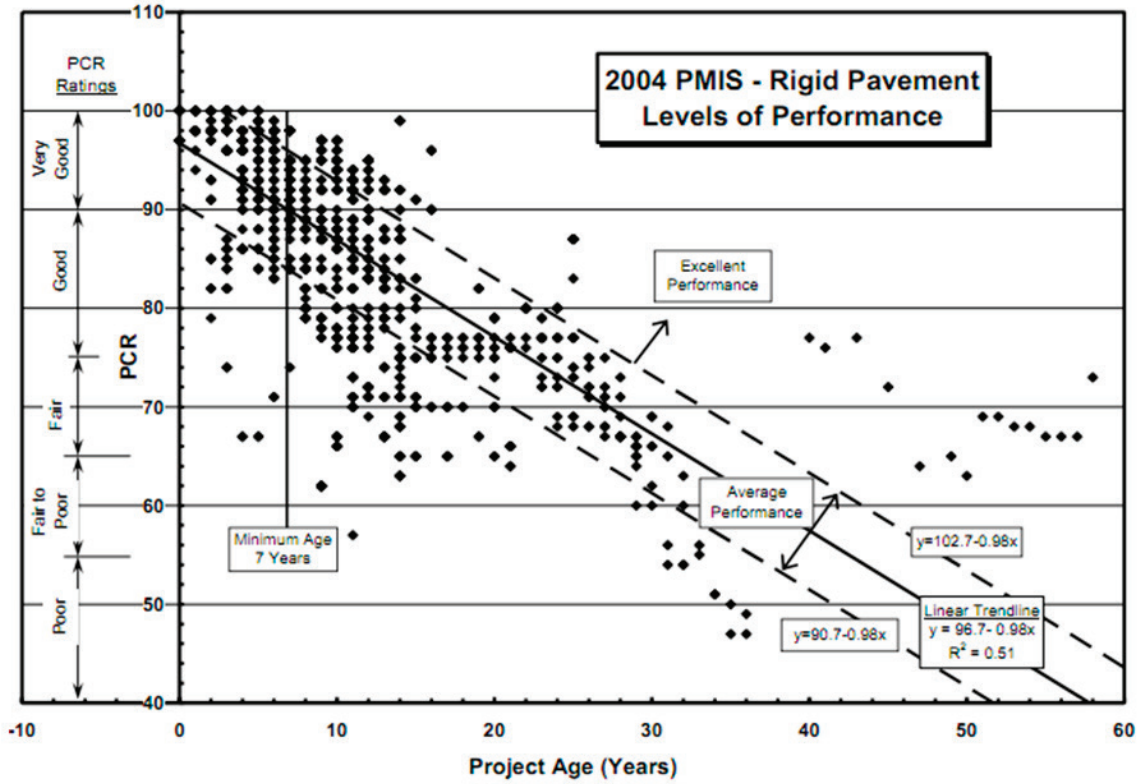
Figure 2. Pavement Condition Rating (PCR) for Rigid Pavements in Ohio. Source Chou et al. [7].

Figure 2 shows the Pavement Condition Rating (PCR) performance data for rigid pavements in the State of

Ohio [7]. The studied sections were a subset of data of those used to define Figure 2. Table 1 presents the location, length, district, year, and initial condition of the pavement sections. The county, roadway and district locations are referred as “Co-Rte” and “Distr.” respectively. The directions are referred as upstation (U), downstation (D) or with the dual index (DU) for the cases when the section was tested in both directions. The year refers to construction date. The condition refers to the initial performance condition of the section as giving by the PCR index.

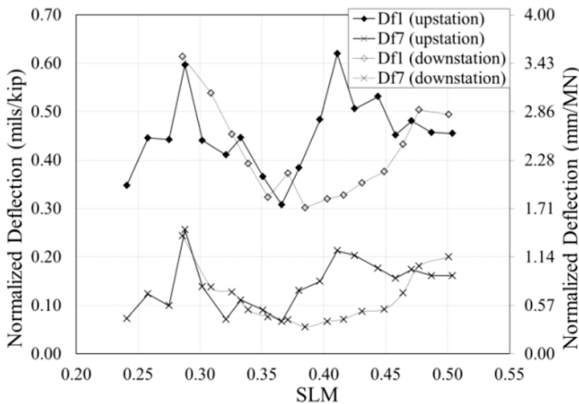
Figure 3. Midslab deflection

Figures 3-8 show a typical set of plots for project # 2 (see Vega-Posada [12] for the complete evaluation) including normalized midslab deflection (Df_1 and Df_7), spreadability, normalized maximum joint deflection, joint transfer, joint support ratio, and subgrade modulus of elasticity, respectively. The modulus of elasticity of the subgrade was back-calculated from the FWD collected data.

Figures 3 and 4 show a decrease in pavement stiffness, both concrete and subgrade layers, between SLM 0.3 and 0.4 in the upstation direction. Figures 5-7 show that the overall condition of the pavement joints is from good to excellent.

Figure 8 presents the back-calculated modulus of elasticity of the subgrade. M_R ranged from 31 ksi (upstation) to 36 ksi (downstation), which in geotechnical terms is considered as a competent layer. From figures 3, 4, and 8, it can be concluded that the stiffness deficiency between SLM 0.3 and 0.4 in the upstation direction is related to a deterioration of the PCC slab and not to a reduction of the subgrade layer capacity. Although the spreadability is classified as good

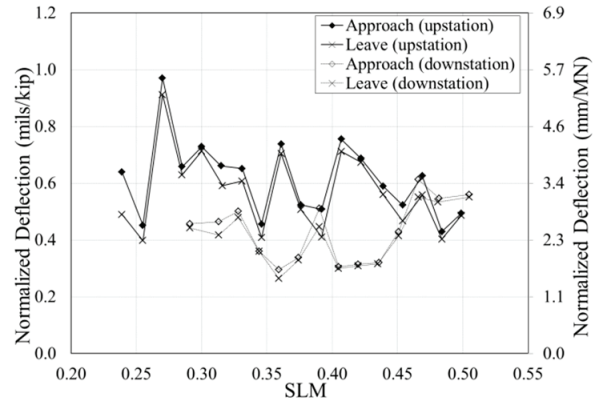
Figure 5. Max. joint deflections

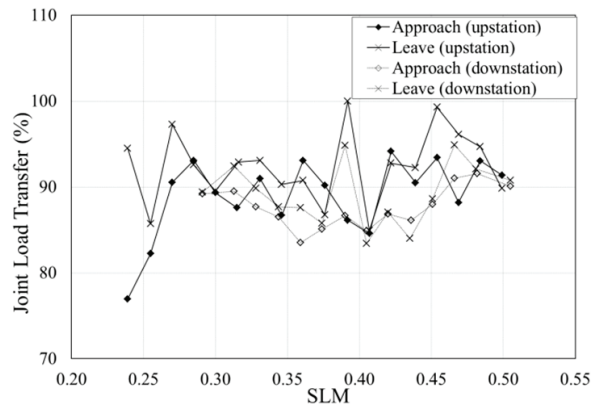
Figure 6. Joint load transfer
